2012

#### Introduction

The Virginia Department of Forestry Best Management Practices Implementation Audit Program is based primarily on the Southern Group of State Foresters published framework for state forestry agencies (http://www. southernforests.org/publications/SGSF%20Regional%20 BMP%20Framework%20Protocol%20publication\_2007. pdf/view). This standardized protocol was intended to ensure that data collected by southern states could be combined into one report. That report is periodically compiled, prepared and submitted to the USDA Forest Service Region 8, as well as to USEPA in Atlanta by the Southern Group of State Foresters. However, this protocol is sufficiently flexible to be applied to each state's individual BMP guidelines. At the direction of the State Forester, Virginia is monitoring 240 harvested tracts each year and compiling an independent annual report based on this protocol. These data are also submitted periodically for the Southern Group five-year report (http://www. southernforests.org/publications).

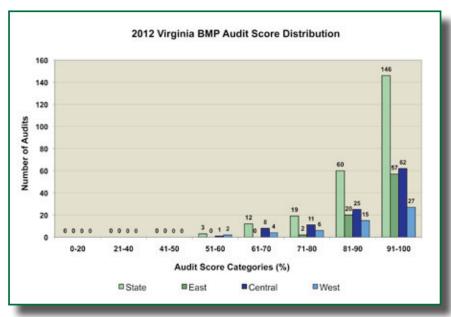
Figure 1: A histogram describing the score distribution of all 240 audits for the 2012 audit cycle in Virginia.

The histogram (Figure 1) indicates that the vast majority of tracts scored an overall implementation of 81 percent or greater. While the overall mean BMP implementation for all tracts is 89.7 percent (Table 2) and the overall tract average score is 90.7 percent, the median tract score is 93.9 percent. Given the skewed distribution of the overall scores in Figure 1, the median is perhaps a better judge of central tendency of the tract score data. These results indicate a substantial increase in BMP implementation statewide over previous years, and it should be understood that random sample averages fluctuate over time and these increases may
